Manhole Inspection Summary

Manhole # S35GG_021MH

Insp Date: **3/15/07 10:30 AM**

Location Address: **1501 LATROBE ST**

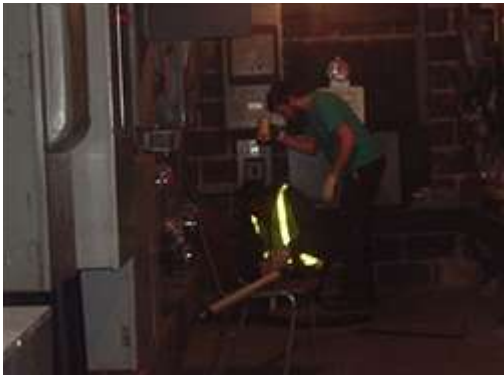
Location View

INSIDE BUILDING

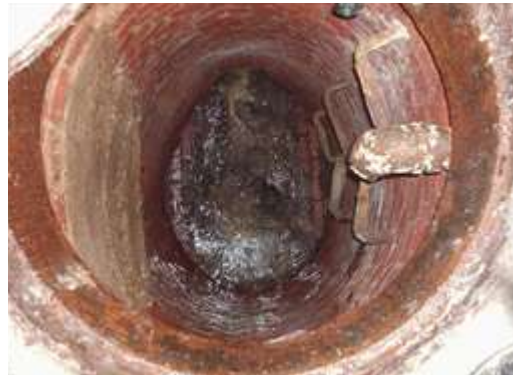
Top View

Corroded steps. Evidence of surcharge - Channel debris.

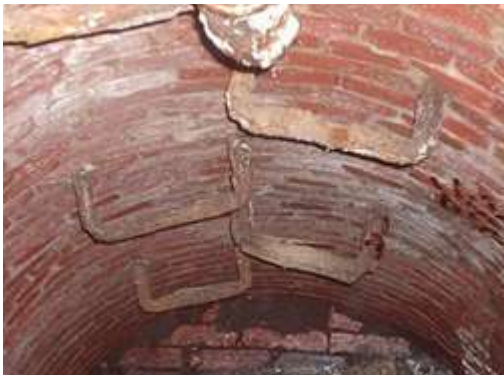
Defect

Barrel infiltration.

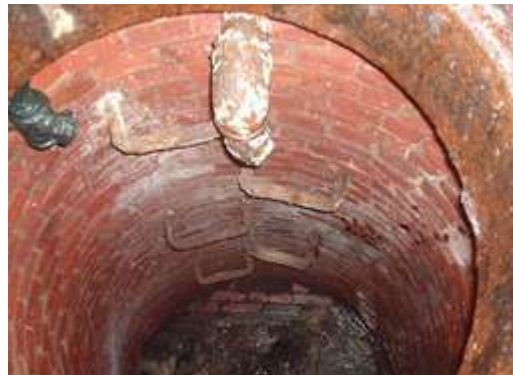
Defect

Adjustment, Corbel and Barrel infiltration.

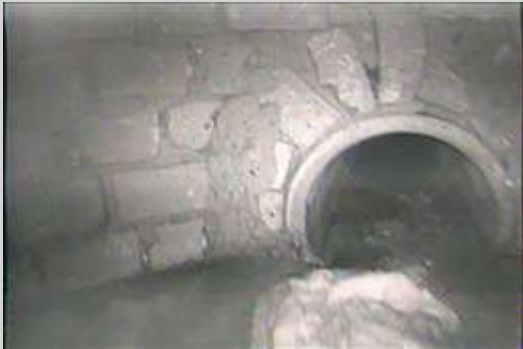
8 in. Circular Gravity Sewer Pipe Out @ 12 O'Clock

Deposits: ☐ None ☒ **Mud** ☐ Sludge ☒ **Debris** ☐ Grease

Silt Depth: **1** (in.) Deposits Extent: **Light**

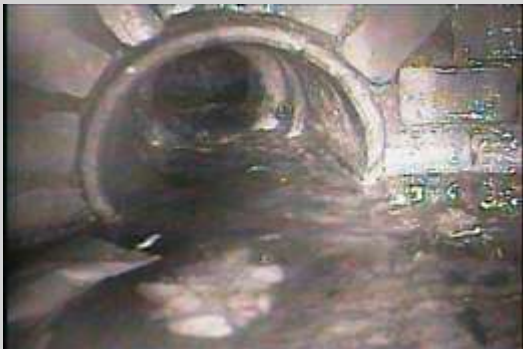
8 in. Circular Gravity Sewer Pipe In @ 6 O'Clock

Deposits: ☐ None ☒ **Mud** ☐ Sludge ☒ **Debris** ☐ Grease

Silt Depth: **0.5** (in.) Deposits Extent: **Light**
